² Name of Dam: Lower North River No. 78 (Briery Branch)

³ Inventory Number: VA 16502

PHASE I INSPECTION REPORT

NATIONAL DAM SAFETY PROGRAM

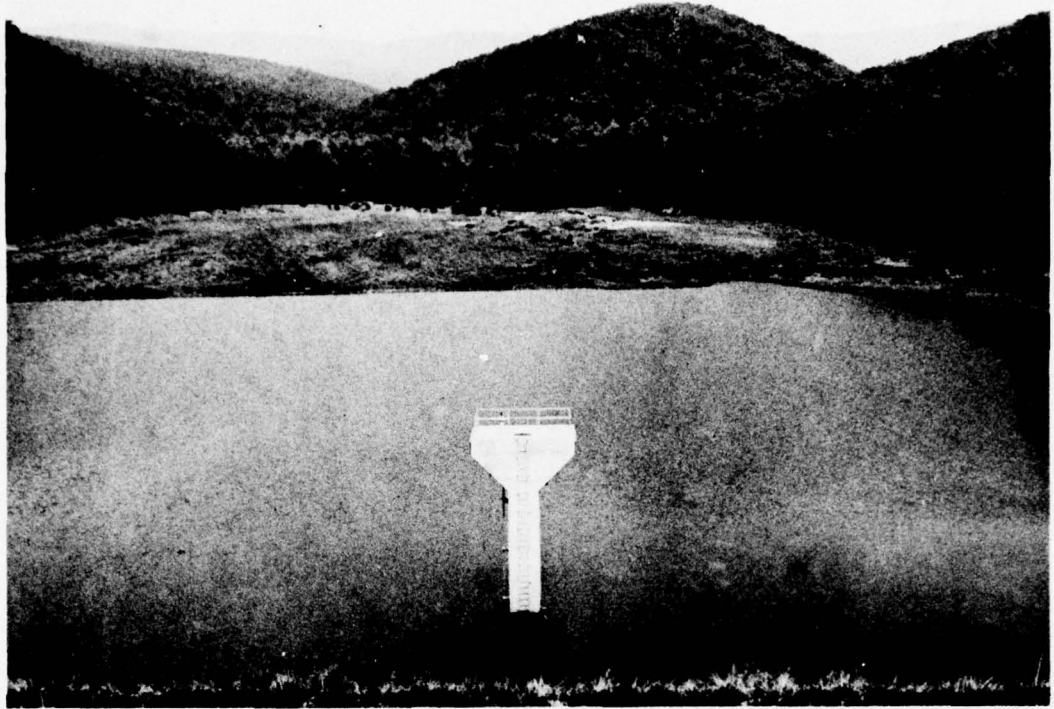
PHOTO 1

Riser and Reservoir From Top of Dam

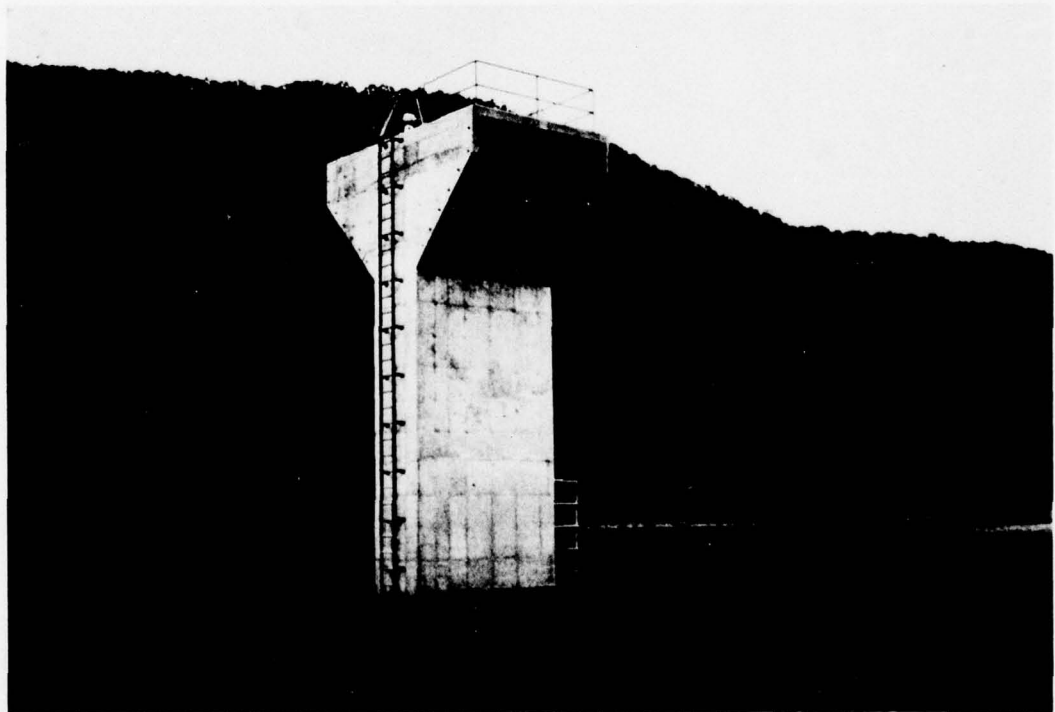
PHOTO 2

- 3.1.3 Appurtenant Structures: The high stage trash rack has several broken bolts that held the horizontal bars in position (see Photo 2). This is probably a result from ice or debris build-up during higher pool levels. Some minor erosion of the banks of the stilling basin (see Photo 3) was observed. This erosion is most likely caused by water levels overtopping the riprap in the stilling basin during high runoff periods.

Riser Showing Trash Rack

It is recommended that the high stage trash rack be repaired and a means to control vehicular traffic be implemented. Small trees growing on the embankment slopes should also be removed.

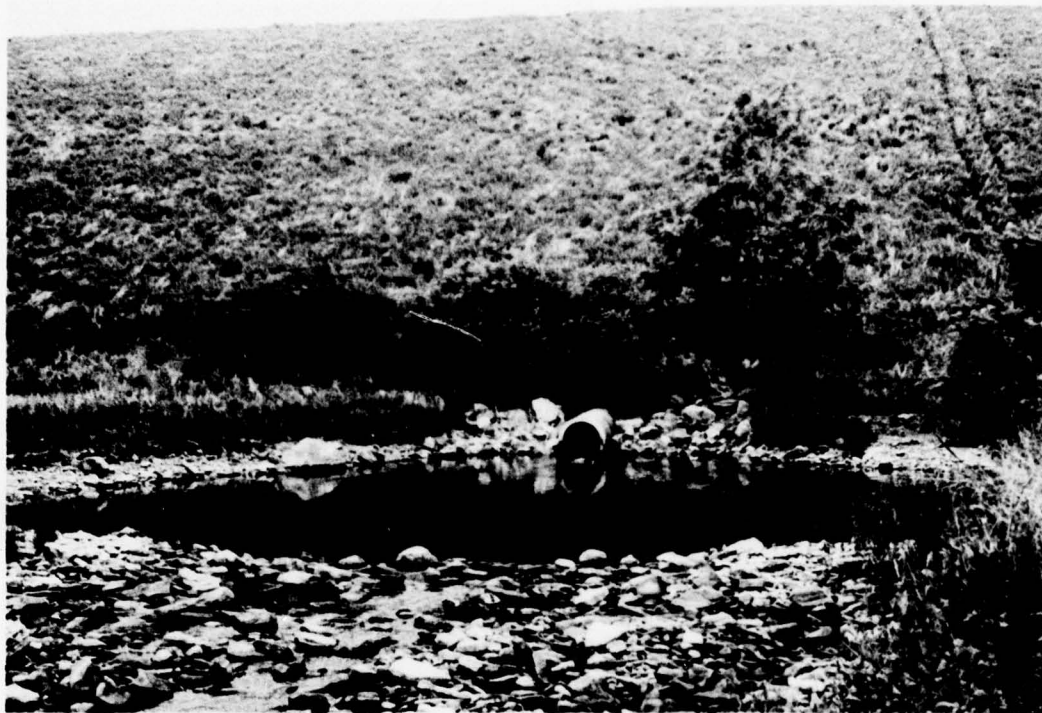
PHOTO 3

Outlet Pipe and Stilling Basin
